Information Bulletin

I.B. No: 020

Aircraft Type: T67B, T67C, T67M, T67M-MkII, T67M200, T67M260 and T67M260-T3A

Title: REDEFINITION OF WING WALKWAY AREA – MOD M899

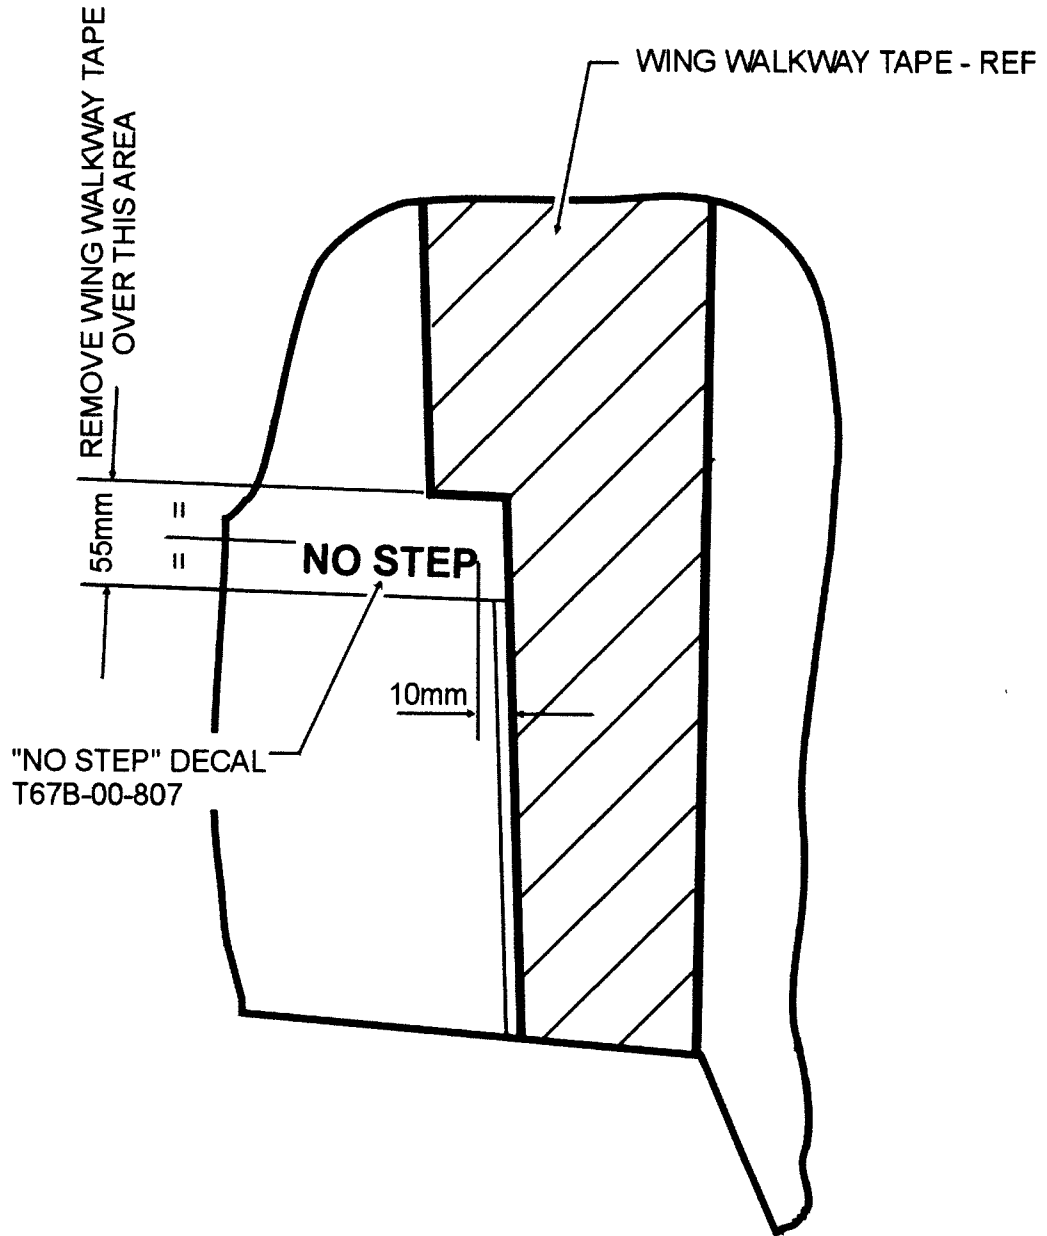
**VIEW ON PORT WING WALKWAY
(STARBOARD OPPOSITE HAND)**

Slingsby have been informed of cracking of paint in the area above the rear spar adjacent to the wing walkway. Subsequent removal of the paint did not reveal any further damage.

The cause has been attributed to the possibility of personnel inadvertently standing outside the designated wing walkway area. In addition, during investigation by Slingsby, it was noticed that the walkway does extend over a relatively unsupported area of the flap shroud and could, when stood on, induce paint cracks.

Therefore it is suggested that the wing walkway area tape may be carefully removed as shown in Fig. 1. Ensure no damage to skin and restore paint finish. A "NO STEP" placard is to be painted on or fitted. A suitable placard is available from SAL as Part No. T67B-00-807. The implementation of this modification to be annotated in aircraft logbook as "Mod M899 incorporated".
