Information Bulletin

I.B. No: 029

Aircraft Type: T67B, T67C Series, T67M, T67M-MkII, T67M200, T67M260 and T67M260-T3A

Title: ADDITION OF "NO PUSH" PLACARD TO ANTI SPIN STRAKES

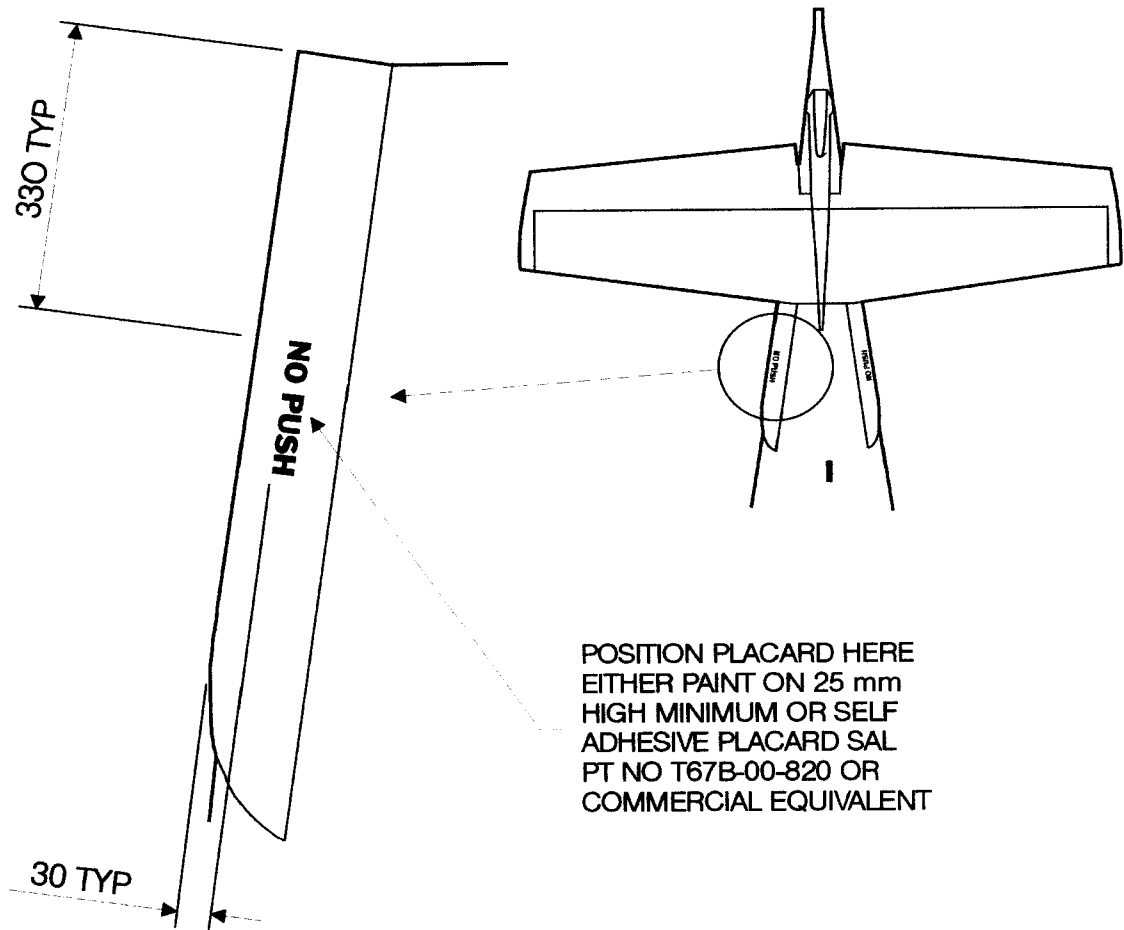
FIGURE 1

There have been reported cases of cracked anti spin strakes. This has been caused whilst ground handling the aircraft. The strakes are not designed to be used for handling.

The strakes are to be inspected for cracking. If cracks are found, then they are to be investigated and if necessary repaired and/or re-painted in accordance with the T67 GRP Repair Manual.

It is essential that the strakes are not to be handled and a "NO PUSH" placard is to be painted on or fitted as indicated by Figure 1. A suitable placard is available from SAL as Part No. T67B-00-820. The implementation of this modification is to be annotated in aircraft logbook as "Mod M1003 incorporated".
