Service Bulletin

S.B. No: 190

INSPECTION OF SAB NOSE UNDERCARRIAGE TORQUE LINKS FOR

CRACKS

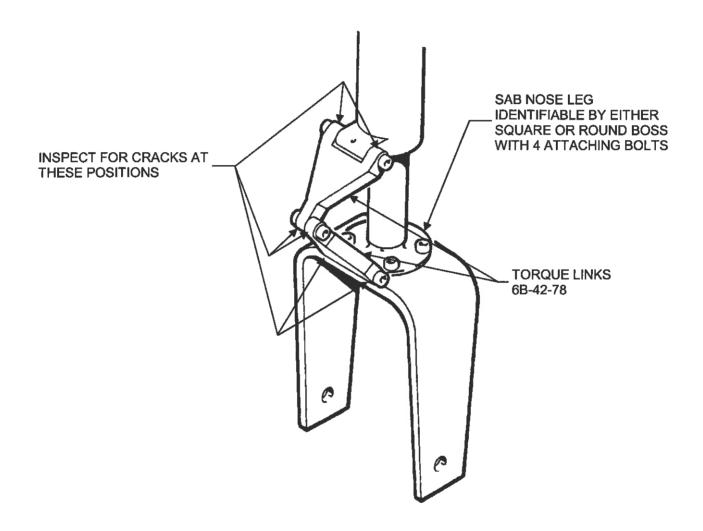
FIGURE 1

The aircraft hours were 3429 flying hours and 5549 flying hours and the undercarriage were as originally fitted at build. Aircraft fitted with the SAB nose leg (Pre Mod M468 or M791) can be identified by the attachment of the lower strut to the nosewheel. Either this attachment will be a square boss (Pre Mod M425) or round boss (Post Mod M425) and with four attachment bolts, ref Figure 1.

SAB NOSE LEG UNDERCARRIAGE TORQUE LINKS SHOWING POINTS OF INSPECTION

- Remove the top and bottom torque links and visually inspect for cracks at positions indicated by Figure 1. Typical crack shown on photograph at Figure 2.
- 2 If any cracking is visible, replace with new item 6B-42-078.
- 3 If no cracking visible, then remove paint from lug areas and perform dye penetrant NDT inspection.

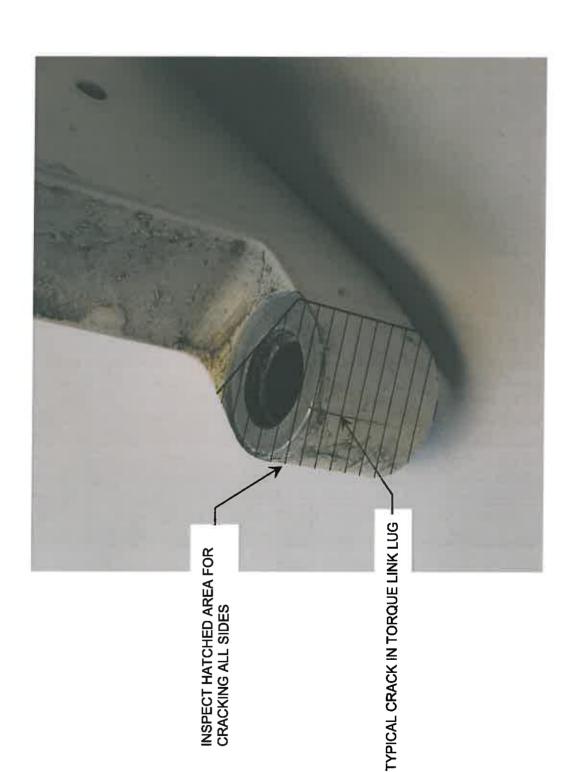
FIGURE 2

This Service Bulletin is issued following information received from a maintenance organisation who during normal maintenance procedures noted cracks in the SAB undercarriage nosewheel leg torque links on 2 Firefly aircraft. The cracks were visible to the naked eye, i.e. in the paint, refer photograph on sheet 3.

- 4 If no cracks noted from inspection at 3 above, clean and repaint inspected area.
- 5 If cracks found from inspection at 3 above remove cracked link and replace with new item 6B-42-078.
- Record in logbook that inspection accomplished at 50 flying hour check, and complete the attached form at Annex A and return it to the address provided. Subsequently inspect at each annual thereafter for cracking, and complete the attached from at Annex A only if cracks are identified.
