# SERVICE BULLETINEII

55

SPECIAL INSPECTION OF THROTTLE CABLE - T67 GRP AIRCRAFT EXCEPT T67C

All T67B, T67C(Pre Mod 480), T67M, T67M MKII, T67M200 alrcraft.

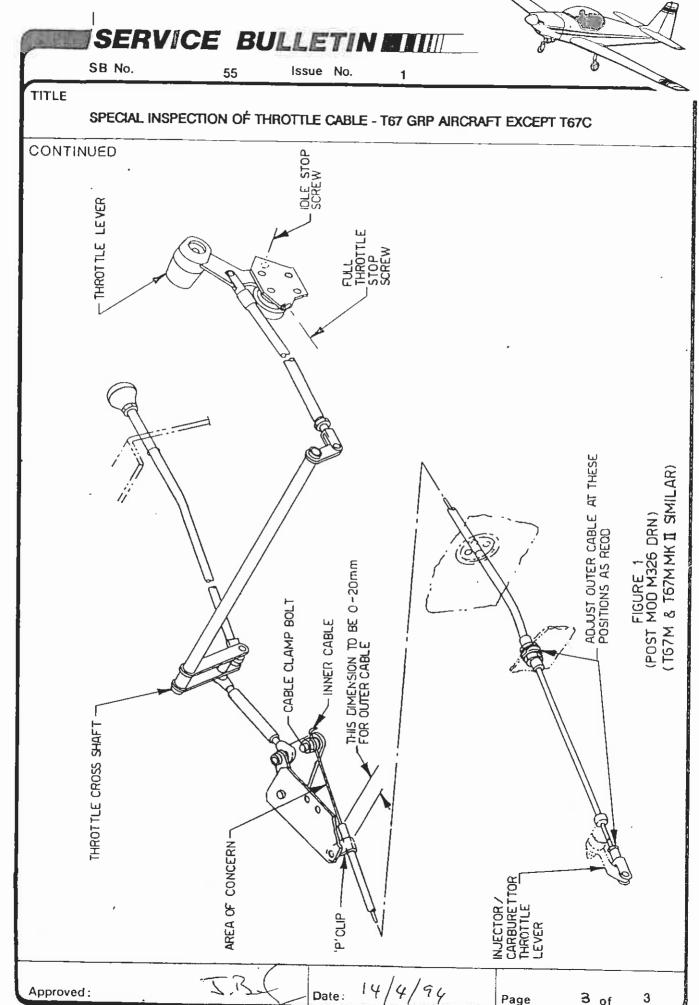
There have recently been cases of breakage of the throttle cable on T67 g.r.p. alrcraft. In these cases the cable has broken at the cockpit end at a point where the inner cable emerges from the outer cable, see Figure 1.

Slingsby Avlation are developing a Modification (Mod M496) which will be applicable to all T67 g.r.p. aircraft which will incorporate an improved fixing of the throttle cable at the cockpit end. Details of Mod M496 will be sent to all Service Bulletin addressees as soon as the modification is available. Incorporation of Mod M496 will discharge the requirements of this Service Bulletin; meanwhile the inspections below are to be carried out as detailed.

- 1. Set the throttle lever to the idle position, and measure the clearance at the idle stop screw.
- 2. Slacken cable clamp bolt, and disconnect the throttle cable at the carburettor/fuel injector.
- Withdraw the cable about 2 cm. this ensures that all the affected part of the inner cable will be visible.
- Visually examine the inner cable for evidence of kinking or cracking if either is found the cable must be replaced.
