SERVICE BULLETIN

154

INSPECTION FOR CLEARANCE BETWEEN SAB UNDERCARRIAGE NOSELEG STEERING PUSHROD AND ENGINE MOUNTING FRAME

Pre Mod M468 and M791 T67A, T67B, T67C Series, T67M, T67M-MkII & T67M200.

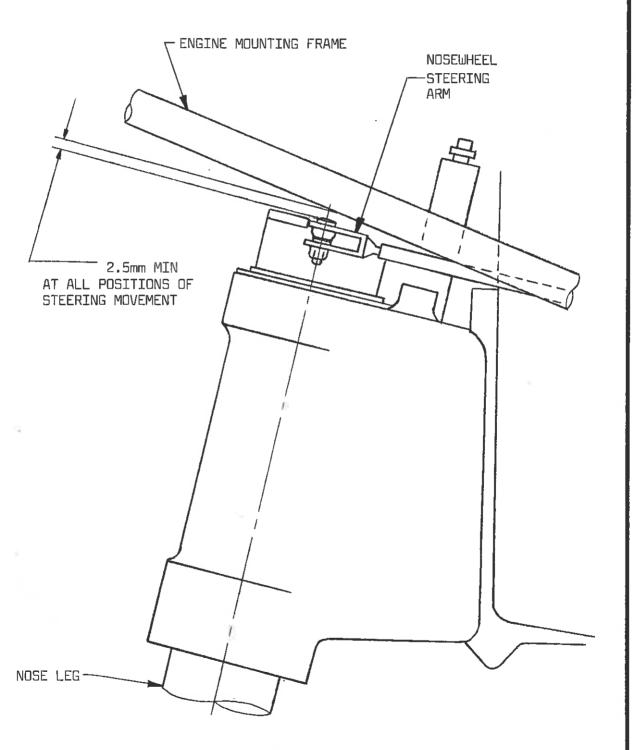
Fig 1 NOSE U/C AND ENGINE MOUNTING FRAME

Cases have been reported of a foul occurring between the nosewheel steering pushrod connecting bolt and underside of the engine mounting frame. This Service Bulletin requires a one time inspection for adequate clearance between these two items. If required clearance is not achieved, further modification will be necessary.

- 1. Position grease plates under the nosewheel of the aircraft. The aircraft must be standing freely on its undercarriage with parking brake on.
- 2. Check the clearance between the nosewheel steering pushrod connecting bolt and the lower engine mounting frame cross tube, as shown in Fig.1. The clearance should be 2.5mm or greater in all nosewheel positions.
- 3. Check the underside of the engine mounting frame in the vicinity of the pushrod for signs of paint removal, scratches and corrosion.
- 4. If adequate clearance exists and there is no sign of damage to the engine mounting frame, annotate aircraft logbook "SB 154 complied with".

If there is insufficient clearance but the engine mounting frame is not damaged, Mod M836 "Introduction of Lowered SAB Steering Collar Swivel" must be incorporated within the next 50 flying hours.

If the engine mounting frame tube has been damaged by the pin, the aircraft must not be flown until the damage has been repaired and Mod M836 incorporated.
