Service Bulletin

S.B. No: 169

INSPECTION OF ENGINE INTAKE DUCT MESH AND ALTERNATE AIR DOOR

T67M, T67M-MkII

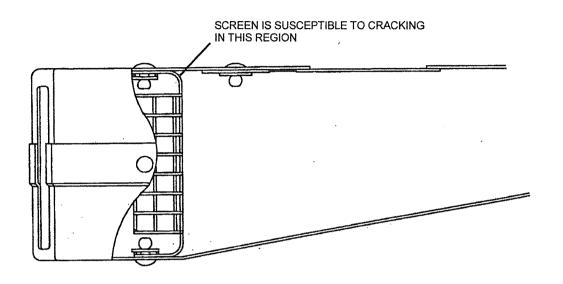
FIG. 1 AIR INTAKE DUCT T67M-50-101

Cases have been reported of both the engine air intake duct mesh cracking and of alternate air door rivets loosening. These cases have been reported only where T67M-50-101 intake ducts have been fitted: however this Service Bulletin also relates to T67M-50-103 intake ducts.

- 8. Should both inspections at paragraphs 4, 5 and 6 be considered to be satisfactory, then proceed as follows:
 - i) If intake duct assy is T67M-50-103 (Ref Figure. 2) no further action is required. Annotate logbook "SB169 complied with".
 - ii) If intake duct assy is T67M-50-101 (Ref Figure 1) then it is necessary to repeat inspection stages 4, 5 and 6 detailed within this Service Bulletin SB169 every 50 hrs flying hours, until Mod M760B air intake repair is invoked. When Mod M760B is incorporated annotate logbook "Mod M760B incorporated".
