Service Bulletin

S.B. No: 92

INSPECTION AND RECTIFICATION OF FUEL VENT AND HYDRAULIC RESERVOIR

TUBE, PLUS VENT PIPE INLET RE-ORIENTATION

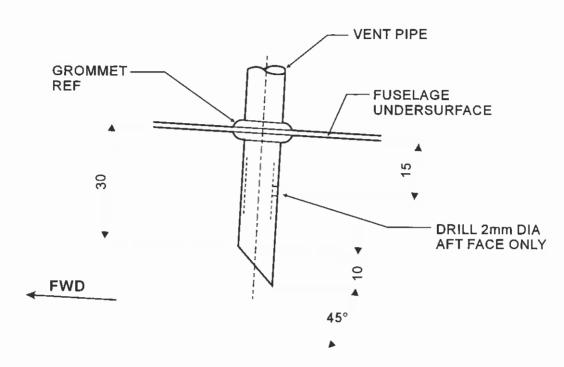
FIGURE 1

During the course of this inspection, ref. T67M260-T3A, ensure the vent pipe inlets are facing forward ref. Figure 1. The pipes are to be re-orientated through 180° to minimise the possibility of fuel in the vent line draining from the aircraft during flight. This action invokes a modification, Mod M701.

Further to Issue 1 of this Service Bulletin, a case has been reported on a T67C aircraft, of the incorrect orientation of the wing fuel vent pipe. This Service Bulletin is now updated to include the checking of the orientation (and length) of the fuel vent pipes on all wing tanked aircraft and to ensure on replacement of the pipe that it is correctly assembled to the aircraft.

- ii. If the vent pipes do not appear to have a yellow cast to them, replace.
- iii. If in doubt, replace.
- 2. Vent pipe inspection.
 - 2.1 **T67M260-T3A only**. During inspection or during course of replacement, re-fit vent tubes with opening facing forward. Drill 2mm diameter hole in aft face. Ref. Figure 1.

T67C wing tank (Post Mod M156) only, T67M-Mkll, T67M200 and T67M260. Inspect the fuel vent pipe for correct orientation and configuration, ref. Figure 1. If incorrect, reassemble as shown. If necessary fit new item (SAL Stock Code 126-36-002, length 230mm), to the configuration shown in Figure 1, ensuring vent tubes opening faces forward and 2mm diameter hole is in aft face.
